# Belzona apply Internal Lining to Heat Exchanger Shell

ID: 8166

Customer Location: Oil refinery, North West England  
Application Date: February 2019

*Internal corrosion to the internals of a heat exchanger*

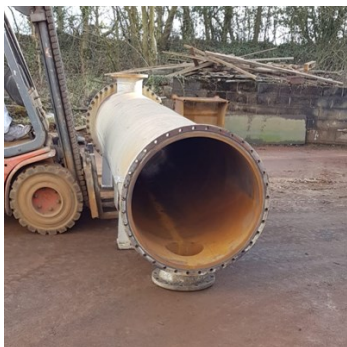
- \* Equipment delivered to Belzona Technosol workshop ,
- \* Extent of the damage ,
- \* First coat of Belzona 1593 ,
- \* Second coat Belzona 1593 ,

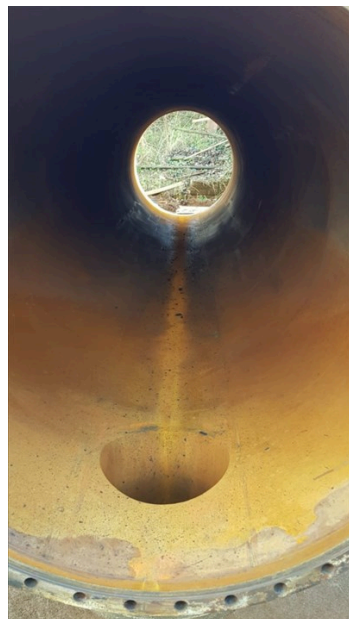
The client had a heat exchanger which was suffering from internal corrosion. They required a solution to repair the internal damage and then apply a suitable internal lining to protect the shell from further damage and extended the equipment's life span.

The heat exchanger was dismantled and delivered to the Belzona workshop in to two parts - the main shell and the dome end. The internal substrate was grit blasted in our workshop under controlled conditions. The pitted steel within the shell was then repaired using Belzona 1511. Following this two Belzona 1511 Nozzle Inserts were bonded into both drain and vent nozzles on the cap end, guaranteeing total encapsulation within these areas. Following the repair, two coats of Belzona 1593 were applied to provide long-term protection. Completed in accordance with Belzona System Leaflet HEX-03
