# Belzona renovate a process tank

ID: 8169

Internal lining of a wheat starch milk tank in a factory

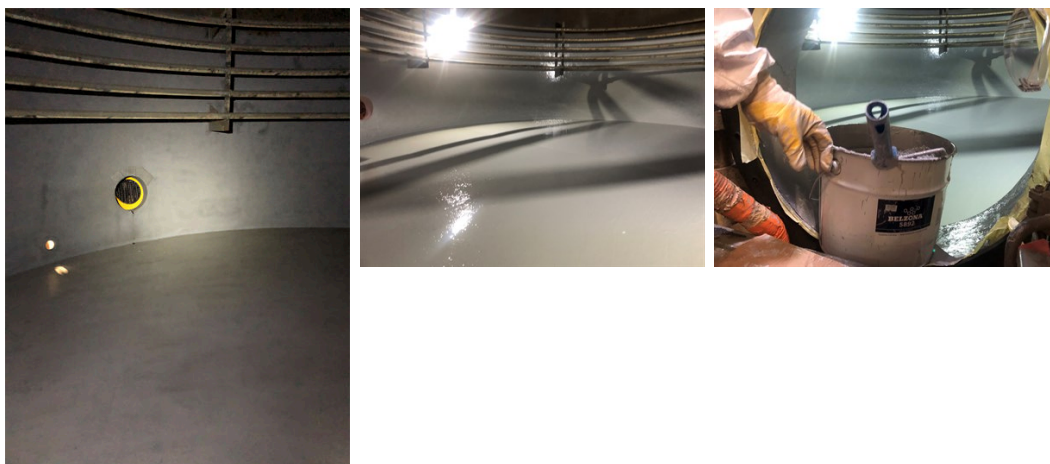
The internal lining of the tank was corroded due to the products being acidic when they are at high temperatures.

\* 1 - Tank after grit blasting 2 - During application of Belzona 5892 3 - Tank after complete coating ,

Application was carried out in accordance with Belzona System Leaflet TCC-5. The tank was previously grit blasted to remove the rust before applying 2 coats of Belzona 5892. Small retouches were made before the coating system was post-cured with steam.
