# Belzona Coats 2 x Pemo Pumps

ID: 8178

Application: CEP-Centrifugal Pumps

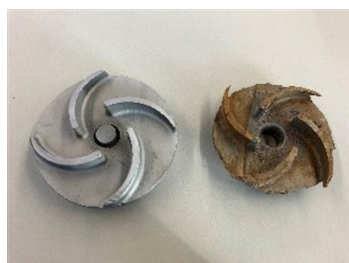
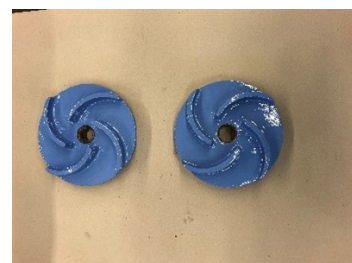
Due to the sand in the water, it damaged the pumps within a short time (6 months). As a result, the pumps were only giving an output pressure of 6 bar of 12 bar. The pumps lost power and the company's production slowed. By slowing down production, the customer made losses every day.

- \* Pemo pumps in the service center. Additional blasting work to better inspect the pumps. Image ,
- \* After blasting, a mold was made for the re-profiling of the impellers with Belzona 1111. Additional construction of the housing passage with Belzona 1111. ,
- \* After re-profiling, the parts were turned to size on the lathe. ,
- \* In addition, the parts were coated with Belzona 1321 Grey and Belzona 1341 Blue. ,

2-stage Pemo pump with heavy leaching.

All components of the Pemo Pumps were previously grit blasted according to SA 2½ / 75µ. After grit blasting, the components were immediately re-profiled with Belzona 1111 and Belzona 9341. This process was repeated several times to achieve the original size. After re-profiling, the parts were turned to the original size on the lathe. After the re-profiling was completed, the pumps would be coated with Belzona 1321 Grey and Belzona 1341 Blue. Application was carried out in accordance with Belzona Know-How system
