# Belzona Coats 2 x Pemo Pumps

Application: CEP-Centrifugal Pumps

2-stage Pemo pump with heavy leaching.

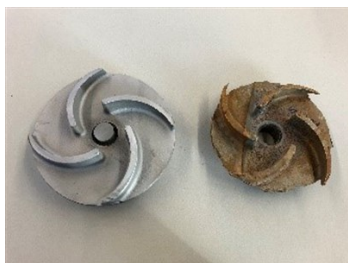
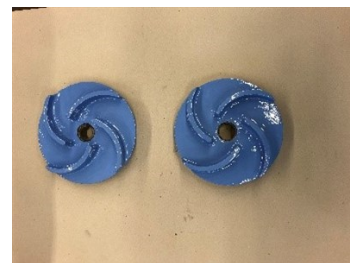
Due to the sand in the water, it damaged the pumps within a short time (6 months). As a result, the pumps were only giving an output pressure of 6 bar of 12 bar. The pumps lost power and the company's production slowed. By slowing down production, the customer made losses every day.

- \* Pemo pumps in the service center. Additional blasting work to better inspect the pumps. Image ,
- \* After blasting, a mold was made for the re-profiling of the impellers with Belzona 1111. Additional construction of the housing passage with Belzona 1111. ,
- \* After re-profiling, the parts were turned to size on the lathe. ,
- \* In addition, the parts were coated with Belzona 1321 Grey and Belzona 1341 Blue. ,

All components of the Pemo Pumps were previously grit blasted according to SA 2½ / 75µ. After grit blasting, the components were immediately re profiled with Belzona 1111 and Belzona 9341. This process was repeated several times to achieve the original size. After re-profiling, the parts were turned to the original size on the lathe. After the re-profiling was completed, the pumps would be coated with Belzona 1321 Grey and Belzona 1341 Blue. Application was carried out in accordance with Belzona Know-How system
