Belzona Coats 2 x Pemo Pumps

Application: CEP-Centrifugal Pumps

Customer Location: Switzerland

Application Date: January 2020

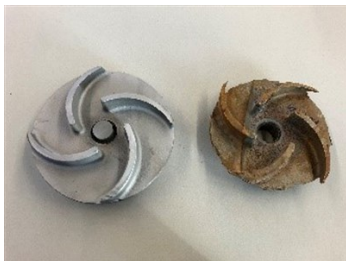
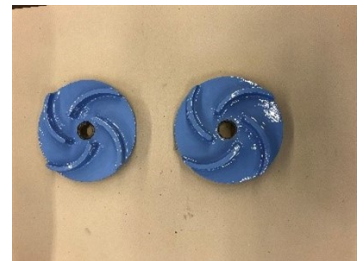
Due to the sand in the water, it damaged the pumps within a short time (6 months). As a result, the pumps were only giving an output pressure of 6 bar of 12 bar. The pumps lost power and the company's production slowed. By slowing down production, the customer made losses every day.

- * Pemo pumps in the service center. Additional blasting work to better inspect the pumps. Image ,
- * After blasting, a mold was made for the re-profiling of the impellers with Belzona 1111. Additional construction of the housing passage with Belzona 1111. ,
- * After re-profiling, the parts were turned to size on the lathe. ,
- * In addition, the parts were coated with Belzona 1321 Grey and Belzona 1341 Blue. ,

2-stage Pemo pump with heavy leaching.

All components of the Pemo Pumps were previously grit blasted according to SA 2½ / 75µ. After grit blasting, the components were immediately re profiled with Belzona 1111 and Belzona 9341. This process was repeated several times to achieve the original size. After re-profiling, the parts were turned to the original size on the lathe. After the re-profiling was completed, the pumps would be coated with Belzona 1321 Grey and Belzona 1341 Blue. Application was carried out in accordance with Belzona Know-How system
