# Belzona Repair Strainers

ID: 8180

Industry: *Marine*  
Application: *SOS-Ships and Offshore Structures*

Substrate: *Cast iron*  
Products: *\* Belzona 1111 (Super Metal) ,*  
*\* Belzona 1321 (Ceramic S-metal) ,*  
*\* Belzona 5811 (Immersion grade) ,*

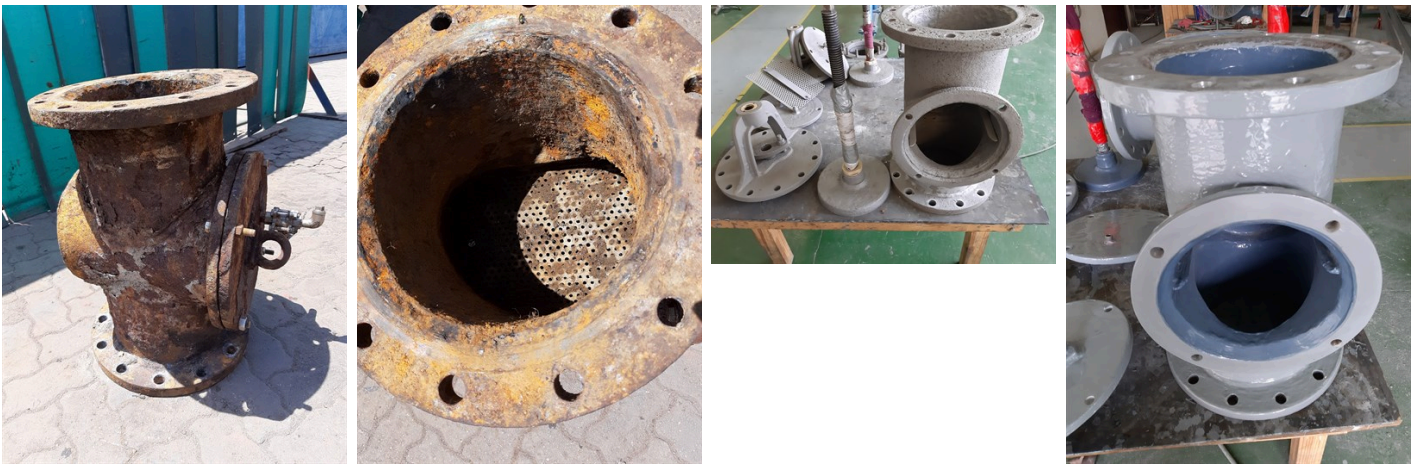
*Strainers badly eroded*

- \* 1. Strainer badly corroded ,
- \* 2. Strainer Flange ,
- \* 3. After grid blast ,
- \* 4. Final product done with Belzona 1111 and Belzona 1321, with Belzona 5811 on the outside. ,

Application was carried out according to the system leaflet SOS-1 & SOS-2

These strainers are very badly damaged and is very costly to repair or manufacture new ones. The only economical way to repair

then is with Belzona.
