Belzona Repair Strainers

ID: 8180

Strainers badly eroded

Fishing vessel strainers

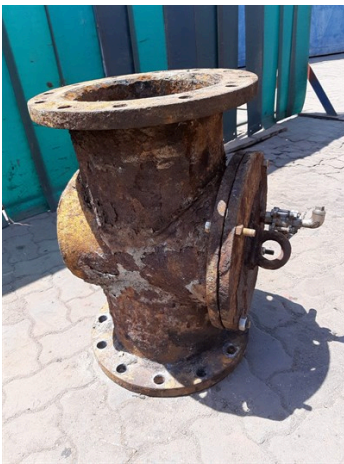
- * 1. Strainer badly corroded ,
- * 2. Strainer Flange ,
- * 3. After grid blast ,
- * 4. Final product done with Belzona 1111 and Belzona 1321, with Belzona 5811 on the outside. ,
