# Belzona repair on a thruster body

Industry: *Marine*  
Application: *SOS-Ships and Offshore Structures*

Substrate: *Steel*  
Products: *\* Belzona 1111 (Super Metal) ,*  
*\* Belzona 1321 (Ceramic S-Metal) ,*

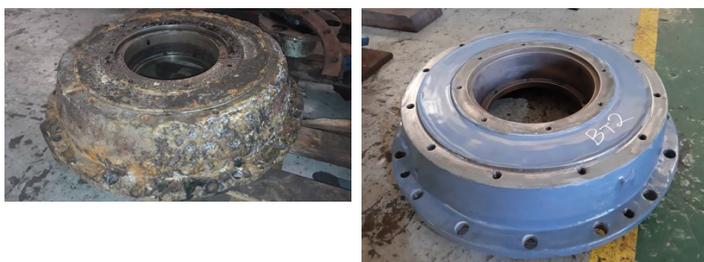
*Heavy wear on body of thruster due to sea water.*

\* 1. Before 2. after repair with Belzona 1111 and Belzona 1321. ,

Thruster body repair.

Application was carried out according to the Belzona Know-How system leaflet SOS-2
