Belzona repair on a thruster body

ID: 8182

Industry: *Marine*
Application: *SOS-Ships and Offshore Structures*

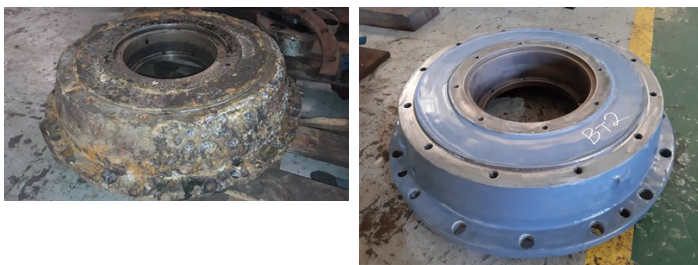
Heavy wear on body of thruster due to sea water.

* 1. Before 2. after repair with Belzona 1111 and Belzona 1321. ,

Thruster body repair.

Application was carried out according to the Belzona Know-How system leaflet SOS-2
