# Belzona repairs a thruster

ID: 8184

Industry: Marine  
Application: SOS-Ships and Offshore Structures

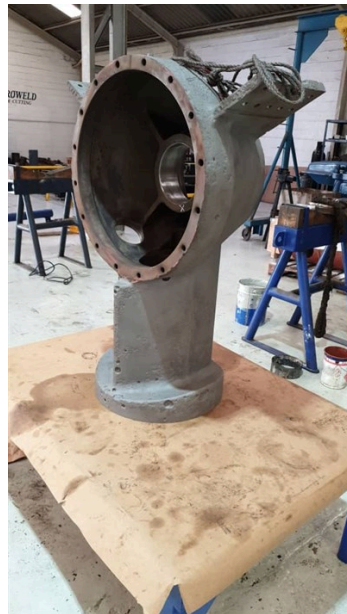
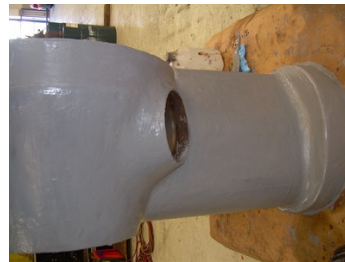
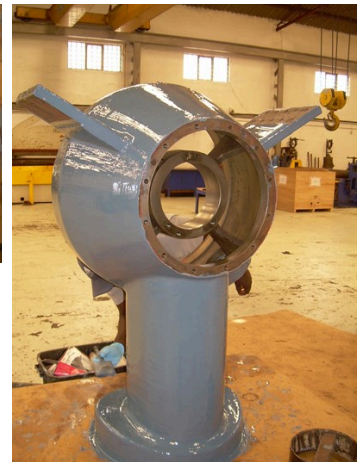
## Photograph Descriptions

Heavily pitted and corroded on the out side of the thruster housing which would be costly and time-consuming to repair.

\* 1. Pitted Housing 2. After grid blast 3. after applying Belzona 1111 4. Final coat Belzona 1321 ,

Stern Thruster for sea going vessel has a large degree of pitting due to erosion-corrosion by sea water.

Application was carried out according to the KHIA Leaflet SOS-1.

This is very costly to replace and also to weld up and grind down to size. Belzona is a very cost effective way to repair and protect.
