# Oil and Gas Wemco Tank Agitator - 3 years Elastomer Wear Pad

ID: 8186

Customer Location: *Gulf of Mexico*

Application Date: *March 2017*

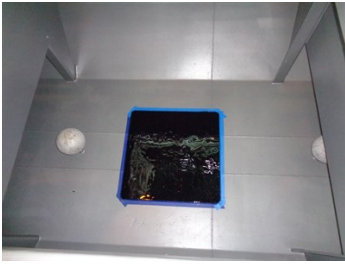
*The agitators create flow patterns on the bottom of the vessel that cause aggressive erosion.*

\* Photo #1: Belzona 2131 wear pad applied in March 2017 Photo #2: Belzona 2131 wear pad after 3 years of service in March 2020  
Photo #3: Small surface defects will be touched up with additional 2131 to ensure another 3+ years of service. ,

Belzona 2131 D&A Fluid Elastomer was applied by brush and applicator in a square patch to cover over the substrate where erosion was noted.
