# Oil and Gas Wemco Tank Agitator - 3 years Elastomer Wear Pad

ID: 8186

Customer Location: *Gulf of Mexico*

Application Date: *March 2017*

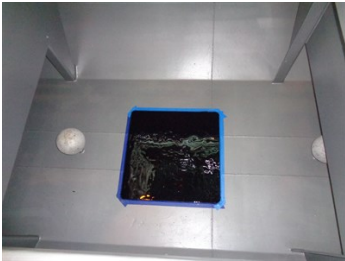
\* Photo #1: Belzona 2131 wear pad applied in March 2017 Photo #2: Belzona 2131 wear pad after 3 years of service in March 2020  
Photo #3: Small surface defects will be touched up with additional 2131 to ensure another 3+ years of service. ,

Belzona 2131 D&A Fluid Elastomer was applied by brush and applicator in a square patch to cover over the substrate where erosion was noted.

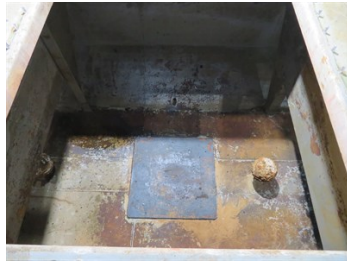
*The agitators create flow patterns on the bottom of the vessel that cause aggressive erosion.*
