# BELZONA SEALS FUEL TRANSPORT HOSE 66FT UNDERWATER

ID: 819

Customer Location: *Oil Refinery, Philippines*  
Application Date: *November 2006*

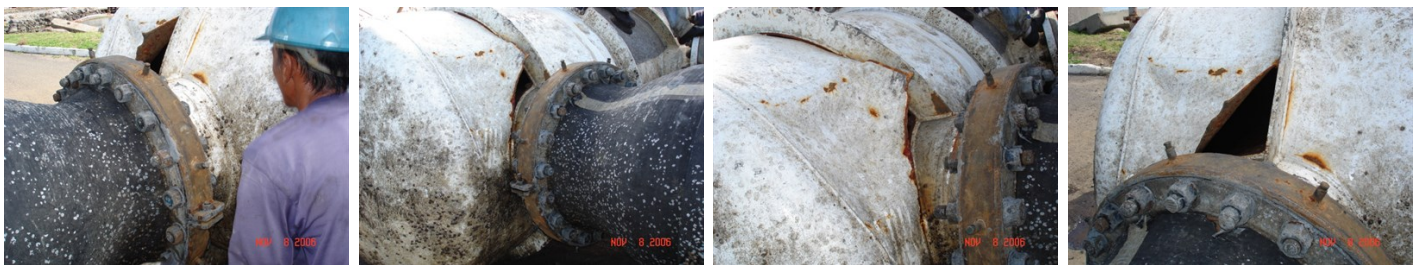
## Photograph Descriptions

*Accident caused leaks on the flange and bolt areas of the fuel transport hose. This posed a severe environmental hazard necessitating immediate action.*

- \*
- \* -4. The Flange brought on-shore. Note the clamp around flange circumference. ,
- ,

The application was carried out in accordance with Belzona Know-How System Leaflet SOS-20. A team of 15 divers sealed individual bolts whilst a clamp was sealed around the flange circumference using Belzona® 1161.
