# BELZONA SOLVES HOLED TANK & HANDRAIL PROBLEM

ID: 821

Industry: *Chemical & Petrochemical*  
Application: *TCC-Tanks and Chemical Containment Areas*  
Substrate: *Steel*  
Products: *Belzona® 1111 (Super-Metal)*

Customer Location: *Chemical Manufacturer (Chromium), UK*  
Application Date: *May 2005*

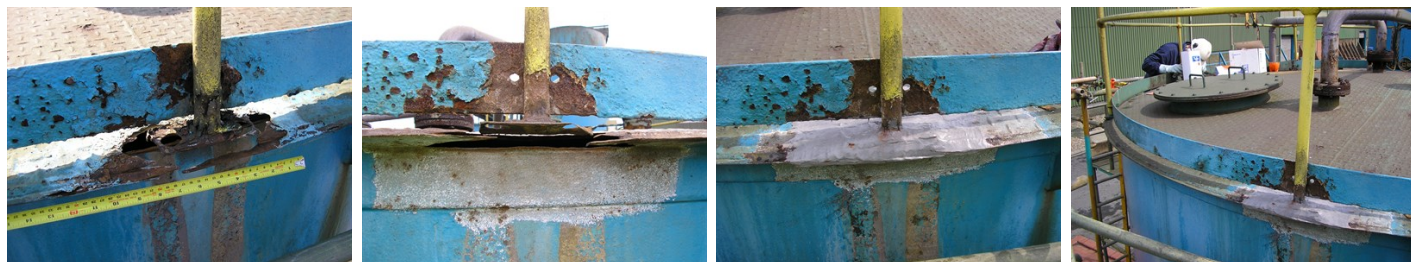
*General corrosion on this old chemical tank had left a hole at the top under a handrail support.*

\* View of corroded area. , \* Surface preparation ongoing. , \* Rebuilding with Belzona® 1111. , \* The completed repair. ,

Holed chemical tank & corroded handrail support.

The application was carried out in accordance with a modified version of Belzona Know-How System Leaflet TCC-5. After a preparation involving needle-gunning & abrading a support plate was bonded onto the underside of the repair area using Belzona® 1111. Once this had cured the whole area was then rebuilt using Belzona® 1111 incorporating reinforcing sheet.

No hot work was allowed when the tank was in use so the customer originally wanted the repair to last to the next shutdown in 9 months at which time they planned to carry out a fabrication repair. After inspection during the shutdown they decided the Belzona repair was sound & a fabricated repair was not necessary.
