# BELZONA PROTECTS OIL/GAS SEPARATORS

Application Date: August 2006

Internal surfaces of first and second stage separators on an FPSO

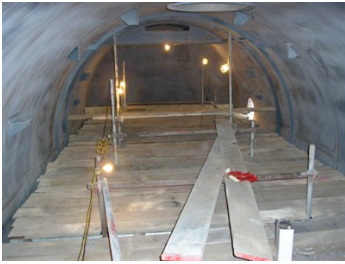
The original glass flake coating had failed in service leading to substrate pitting and corrosion.

\* General view inside separator , \* Stripe coating , \* First coat application ongoing , \* Second coat completed ,

Belzona® 1391 was chosen because of its proven record in high temperature environments and particularly resistance to explosive decompression.
