# Belzona® Provides Quick and Easy Repair of Vertical Pump Shaft

ID: 8233

Customer Location: A large scale power plant in Anhui, China

Application: MPT-Mechanical Power Transmission

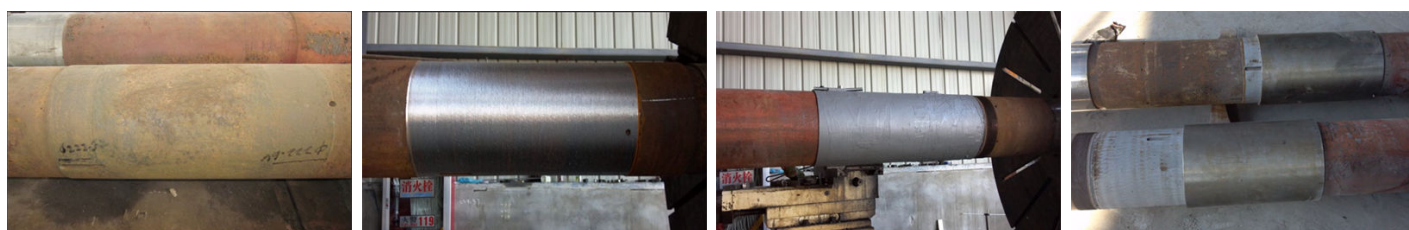
## Photograph Descriptions

Most parts of the vertical water pump shaft sleeve appear over 1 mm abrasion, causing serious vibration during operation, which leads to increase in energy consumption of the electric engine and safety risks. Due to the large abrasion area and its thickness, brush plating and bead welding repair are unavailable.

\* 1. Shaft diameter decrease and becomes irregular; 2. Achieve thick thread after cutting; 3. Spline rebuild and repair completed; 4. Processing complete matching the shaft sleeve perfectly ,

Belzona solution solves the problem in a simple way, eliminated the need for welding and avoided thermal deformation. Since 2013, 9 of the 12 shafts from 4 pumps in this power plant have been repaired, saved customer the high cost of replacing shafts, and these shafts have been in good service since repaired.
