Belzona Internal Pipe Refurbishment to Intake Relief Valve Tubes

ID: 8243

Customer Location: Hydro Power Station, UK
Application Date: September 2019

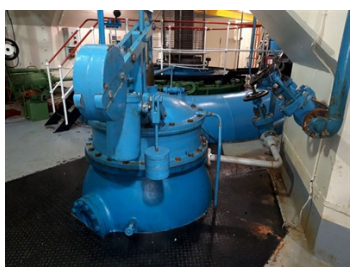
Each intake relief valve tube was leaking from a step between the tube and the valve causing water ingress to the interior area of the turbine hall. The tubes had been previously coated with Belzona 1321 around twenty years prior and unable to assess condition due to both being underwater.

- * 1 – Intake Pipe Interior Turbine Hall ,
- * 2 – Two Underwater Intake Pipe Chamber Accesses ,
- * 3 – Standard of Substrate Preparation ,
- * 4 – Belzona 1321 Two Coat System Finished ,
