# Belzona 5871 Protects Local Paper Mill NCG Header Piping

ID: 8250

Customer Location: *Alabama, United States*  
Application Date: *April, 2020*

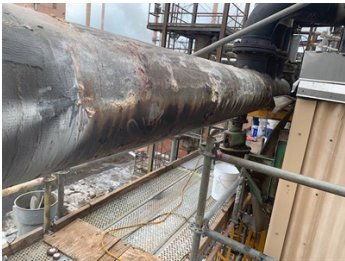
*Some thin wall and through-wall defects (live leaks) were found on weld joints upon removal of the existing insulation.*

- \* Corroded pipe condition after insulation removal ,
- \* Surface preparation ,
- \* Temperature reduction on the pipe after 5871 application ,
- \* Insulated piping ,

Non-condensable gas header piping of dimensions 16 inch. OD and 100 ft. length and operating at 208 °F was suffering from corrosion under insulation.

Wall thickness readings were taken prior to any work being completed. Belzona 1511 was used to rebuild thin wall defective areas prior to the application of Belzona 5871. Due to non-sparking requirements onsite, the substrate was prepared using MBX bristle blaster and wire brushing.
