Sealing a transformer using Belzona

ID: 8251

Transformer connections

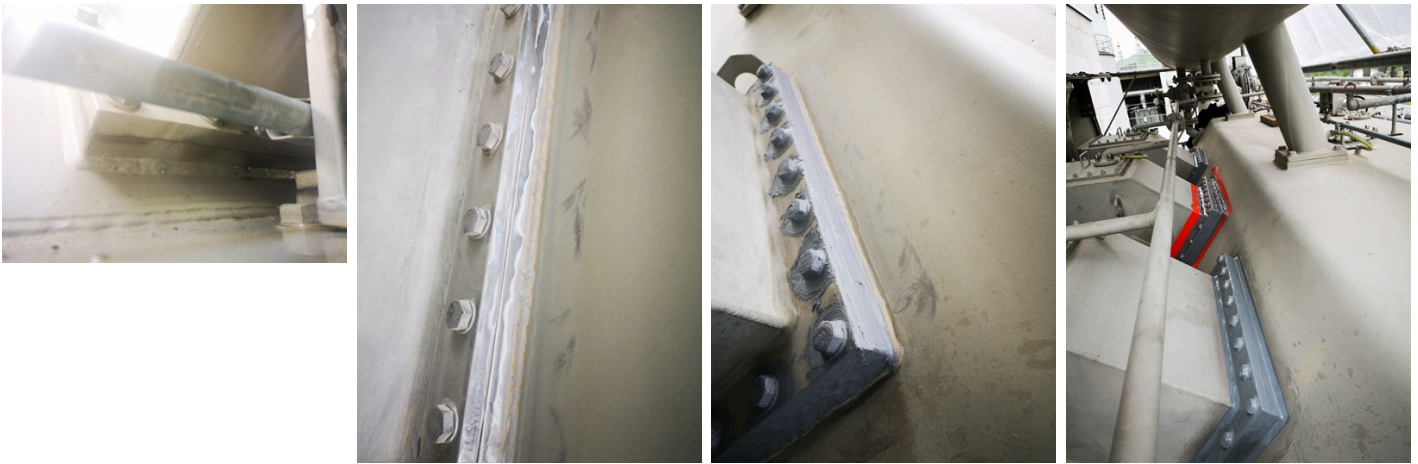
Various places from which oil has escaped due to a defective seal.

Photograph Descriptions

- * Assessment of the leak places ,
- * Machine grinding and cleaning the surface, and seal with Belzona 1212 ,
- * Connection and screw heads with Belzona 1161 ,
- * Screws and connection with Belzona 5831 seal ,

The surface would be sanded and cleaned mechanically, the exiting areas were sealed with Belzona 1212. In addition, the entire joint was sealed with Belzona 1161 and overcoated with Belzona 5831. The application was completed in accordance with Belzona System Leaflet GSS-08.
