# Sealing a transformer using Belzona

ID: 8251

Transformer connections

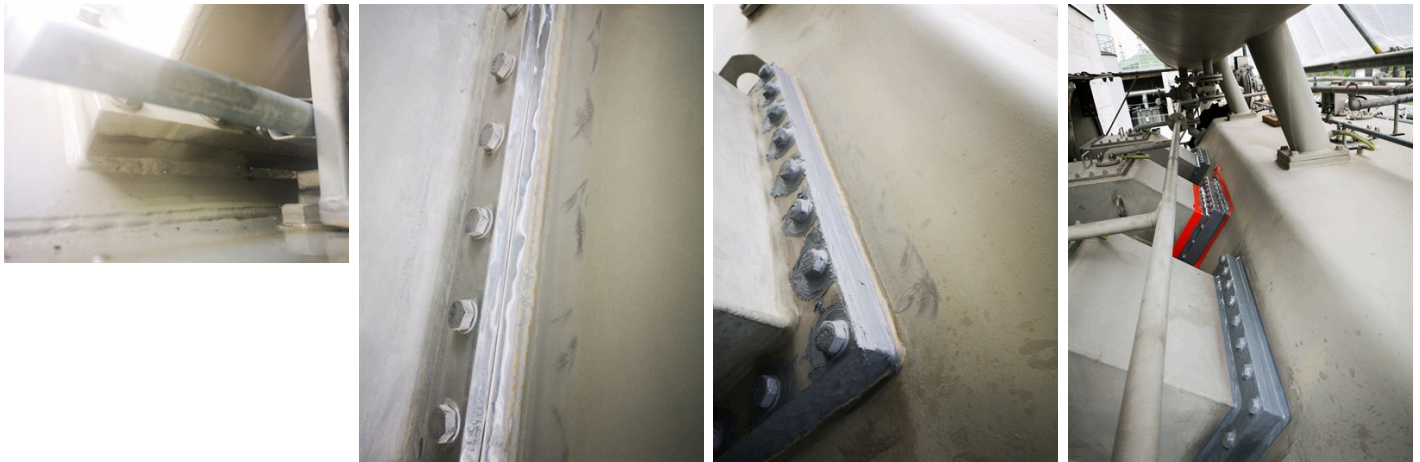
Various places from which oil has escaped due to a defective seal.

- \* Assessment of the leak places ,
- \* Machine grinding and cleaning the surface, and seal with Belzona 1212 ,
- \* Connection and screw heads with Belzona 1161 ,
- \* Screws and connection with Belzona 5831 seal ,

The surface would be sanded and cleaned mechanically, the exiting areas were sealed with Belzona 1212. In addition, the entire joint was sealed with Belzona 1161 and overcoated with Belzona 5831. The application was completed in accordance with Belzona System Leaflet GSS-08.
