# Belzona Repairs Desulfurization and Denitrification Pump Casing and Provides Long-term Protection

Customer Location: *Xianyang, Shaanxi, China*

## Problem

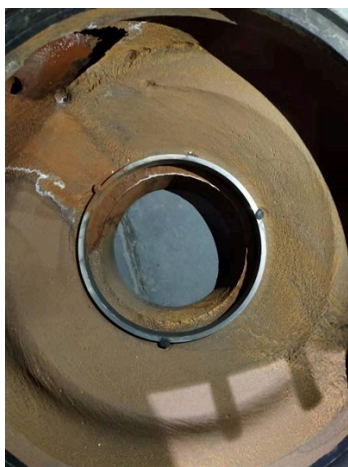
*Leaking pump casing and seriously corroded runner.*

- \* Damaged pump casing ,
- \* Gritblasting internal part of the casing ,
- \* Repair the leakage of the pump casing ,
- \* Application complete ,

The desulfurization and denitrification pump experienced chemical corrosion and erosion caused by corrosive media during the process of transporting fluid. Because of the lack of protection or failed anti-corrosion treatment, the pump was seriously corroded, which caused potential safety risks.

The asset owner used patch welding to repair the leaking pump previously which could only help for a short period of time. After using Belzona to repair and protect the pump, which requires a short application window, the leakage is repaired and the internal part of the pump casing was effectively protected for the long-term.
