Belzona Restores a Tank Roof in Hungary

ID: 8260

Customer Location: Hungary
Application Date: October 2016

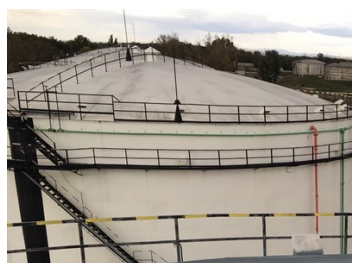
The tanks roofs were heavily polluted with a dirty grayed appearance generating higher temperature and so more evaporation of high volatile fuel in the summer period. This is a huge loss of product for the asset owner.

- * Polluted tank roof (before) ,
- * Belzona 6111 Liquid Anode used as a primer on the blasted surface. ,
- * Belzona 5111 Ceramic Cladding White was sprayed. ,
- * Condition check after 4 years. No problem, perfect performance. ,
