Belzona Repairs and Protects Pipe Tee for Mixed Aldehyde

ID: 8261

Customer Location: Shandong, China
Application Date: October, 2019

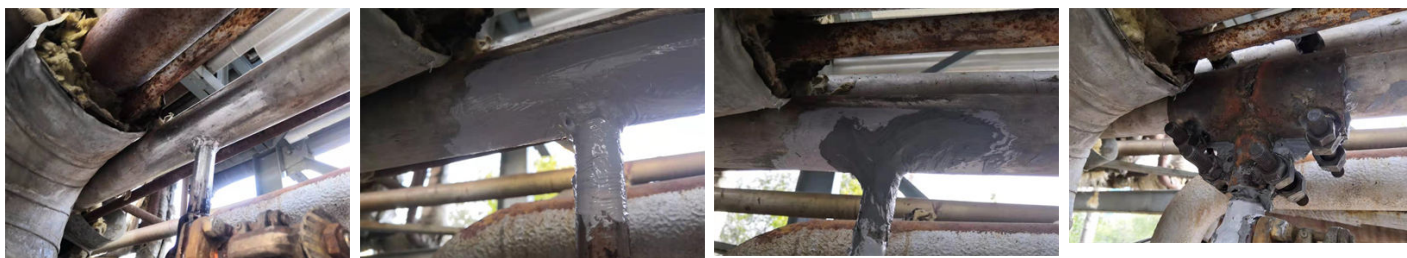
Photograph Descriptions

There is leakage at the pipeline weld, which needs to be repaired and reinforced.

- * Surface preparation ,
- * Belzona 1593 offers corrosion-resistance protection ,
- * Belzona 1111 applied to reinforce pipeline ,
- * Application complete with fitting applied ,

Application was carried out in accordance with Belzona Know-How System Leaflet VPF-11. First, the leaking area should be sealed after surface preparation; Then, Belzona 1593 was applied to protect the pipeline from future corrosion; And last but not least, Belzona 1111 was applied to reinforce the connection area between fixtures and the pipeline.
