# Belzona Repairs and Protects Centrifugal Pump

Industry: Sugar  
Application: CEP-Centrifugal Pumps  
Substrate: Steel  
Products: \* Belzona 1111 Super Metal and Belzona 5821 ,

Customer Location: Pune Rural, India  
Application Date: October 2018

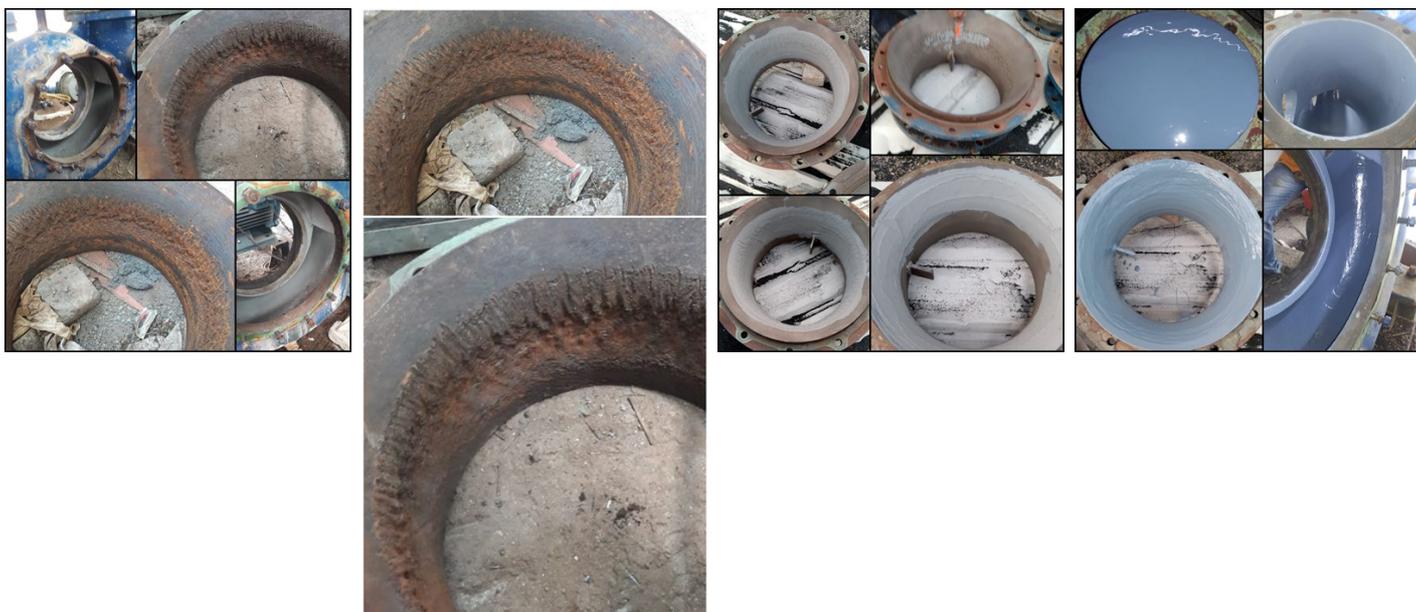
## Photograph Descriptions

Feed water at max. 45 deg C was pumped through these pumps for the sugar processing plant. Due to design fault, there was lot of turbulence at discharge which resulted in heavy erosion and corrosion of discharge mouth. They had to replace that part every year. The customer needed a solution that could extend the life as well as be within their budget.

- \* 1) Pumps at the time of inspection ,
- \* 2) High erosion on mouth ,
- \* 3) Metal rebuilding done with Belzona 1111 ,
- \* 4) Coating completed ,

Grit blasting done to prepare the surface to 75 micron profile and SA 2.5 cleanliness. Belzona 1111 used to rebuild the surface. Two coats of Belzona 5821 applied to the pump.
