BELZONA KEEPS DECKING SAFE

Application: FPA-Floor Problem Areas

Customer Location: Holiday Village, Penrith

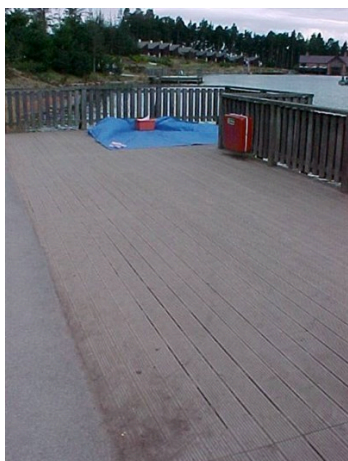
Slipping hazard, particularly when wet. Also wear on top surface.

- * Slippage problem area. ,
- * Belzona grip system was mixed and piped using polyethylene bag, and then spread with an applicator. Further aggregate was then spread over the area. ,
- * Completed application. ,
