BELZONA KEEPS DECKING SAFE

Industry: *Buildings & Structures*
Application: *FPA-Floor Problem Areas*
Substrate: *Wood*
Products: ** Belzona® 5811 (Immersion Grade) ,*
** Belzona® 9211 (Supergrip Aggregate) ,*

Customer Location: *Holiday Village, Penrith*
Application Date: *2002*

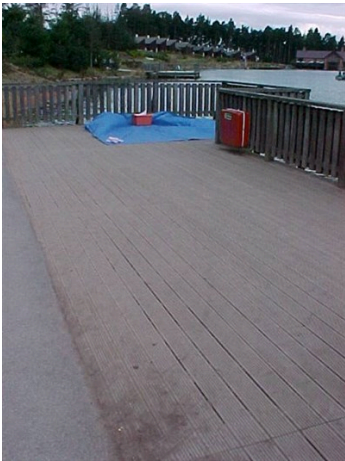
Slipping hazard, particularly when wet. Also wear on top surface.

- * Slippage problem area. ,
- * Belzona grip system was mixed and piped using polyethylene bag, and then spread with an applicator. Further aggregate was then spread over the area. ,
- * Completed application. ,
