# BELZONA 5871 PROTECTS STEAM PIPING HAZARDOUS TO OPERATORS

ID: 8288

Customer Location: Alabama, USA  
Application Date: May, 2020

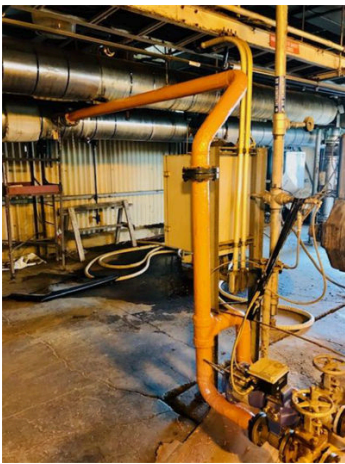
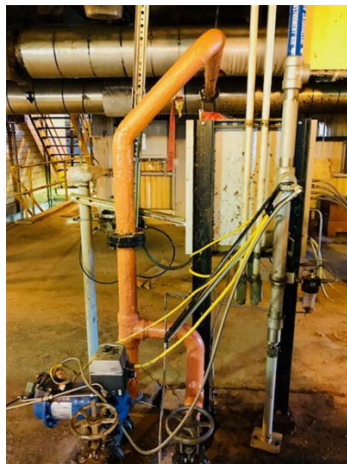
- \* Pipe coated with Belzona 5871 ,
- \* Pipe coated with Belzona 5871 ,
- \* Measuring temperature after application of Belzona 5871 ,
- \* Measuring temperature after application of Belzona 5871 ,

Steam piping of four identical sections of a batch digester at a local paper mill, operating at 200°F max.

The line was shut down for safety handling during application procedure. Belzona 5871 was applied in 4 coats in one day, with a total DFT of 160-180 mils.
