BELZONA 5871 PROTECTS STEAM PIPING HAZARDOUS TO OPERATORS

ID: 8288

Industry: Pulp & Paper
Application: VPF-Valves, Pipes and Fittings
Substrate: Steel
Products: * Belzona 5871 ,

Customer Location: Alabama, USA
Application Date: May, 2020

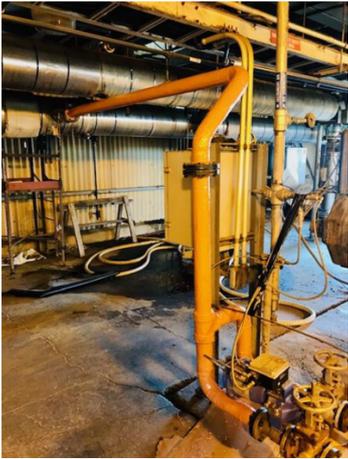
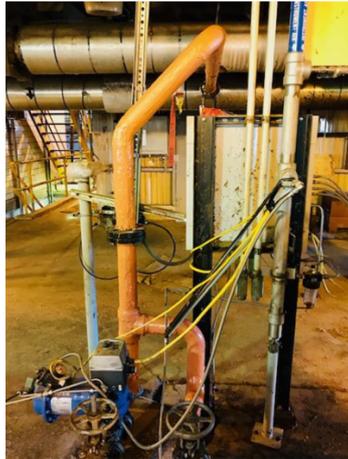
- * Pipe coated with Belzona 5871 ,
- * Pipe coated with Belzona 5871 ,
- * Measuring temperature after application of Belzona 5871 ,
- * Measuring temperature after application of Belzona 5871 ,

Steam piping of four identical sections of a batch digester at a local paper mill, operating at 200°F max.

The line was shut down for safety handling during application procedure. Belzona 5871 was applied in 4 coats in one day, with a total DFT of 160-180 mils.

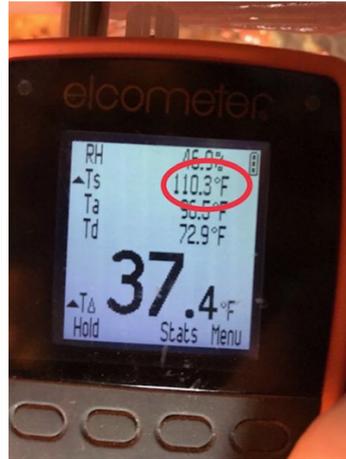
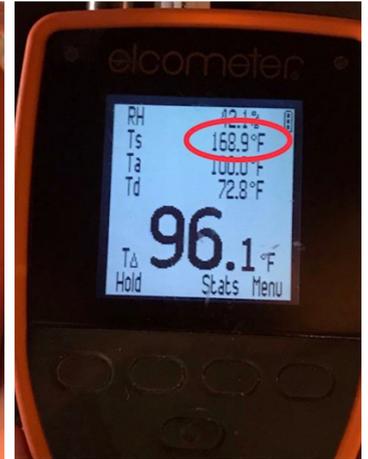
were applied in one day, and 4 more identical pipe sections were repaired during a planned maintenance. Belzona was able to reduce the temperature down to 110F, preventing any type of contact surface burn and protecting the pipe against future corrosion degradation.
