# Belzona 1212 Keeps The Dredging Pontoon Afloat

ID: 8297

Sand and gravel dredge.

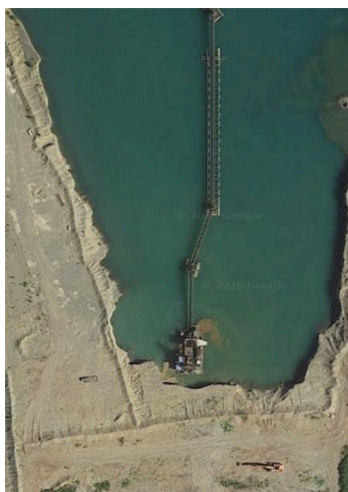
After many years of use, the pontoon on this dredge had been struck by boats and possibly run against the bank causing dents and damage to the original coating. Over time this caused corrosion and developed holes allowing water to leak into the pontoon. Due to the original coating being coal tar, and the location of the holes, welding was not a safe option. The leaks into the pontoon had grown enough to the point that in order to keep the dredge afloat, the pontoon had to be pumped out at the end of every shift.

- \* Google view of the dredge ,
- \* The damaged areas prepped ,
- \* Application completed ,
