Belzona Repairs Cavitation Damage On Cargo Ship

ID: 8298

Industry: *Marine*
Application: *SOS-Ships and Offshore Structures*

Customer Location: *Shipyards, TURKEY*
Application Date: *August 2019*

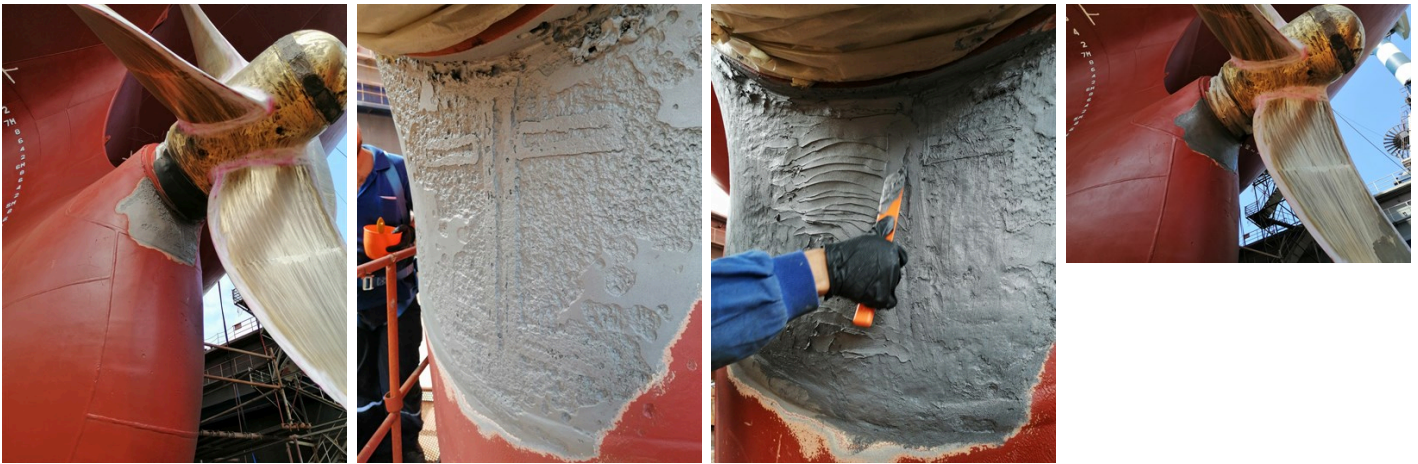
Photograph Descriptions

High cavitation damage under the stern flange of the propeller shaft

- * Cavitation damage surface ,
- * After surface preparation ,
- * Application of Belzona 1311 ,
- * After Belzona application ,

Area under the propeller shaft flange of a Cargo Ship

Application was carried out in accordance with Belzona Know-How system Leaflet SOS-01. Application surface prepared with grit blasting to achieve SA2½. Surface then cleaned with Belzona 9111. Belzona 1311 was used to repair the damaged surface.

Repair with welding is time consuming and may not be a definitive solution. Repair of the damaged area with Belzona provides easier, faster and protective solution against cavitation damages.
