# BELZONA SAFEGUARDS BOTTLING PLANT

**Industry:** *General Industry*  
**Application:** *GSS-Gaskets, Seals and Shims*  
**Substrate:** *ST 37 Steel*  
**Products:** *\* Belzona® 1111 (Super Metal) ,*  
*\* Belzona® 1321 (Ceramic S-Metal) ,*

**Customer Location:** *Bottling Plant, Amman*  
**Application Date:** *January 2007*

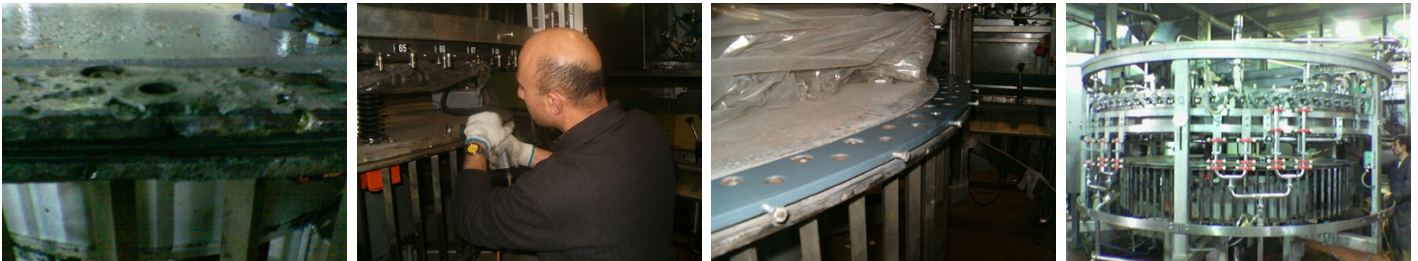
*Extensive deep pittings and corrosion all over the large ring led to loss of pressure.*

- \* Damaged ring ,
- \* Surface preparation ,
- \* Filling, forming, and coating completed ,
- \* Back in operation after two days ,

Bottling ring 2.7 meters diameter severely eroded and corroded.

Application was carried out in accordance with Belzona Know-How System Leaflets GSS-8, GSS-9 & ENC-2.
