# BELZONA SAFEGUARDS BOTTLING PLANT

ID: 830

Customer Location: Bottling Plant, Amman

Application Date: January 2007

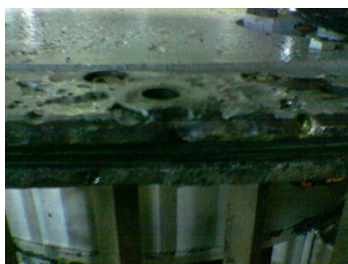
*Extensive deep pittings and corrosion all over the large ring led to loss of pressure.*

- \* Damaged ring ,
- \* Surface preparation ,
- \* Filling, forming, and coating completed ,
- \* Back in operation after two days ,

Bottling ring 2.7 meters diameter severely eroded and corroded.
