BELZONA SAFEGUARDS BOTTLING PLANT

ID: 830

Customer Location: Bottling Plant, Amman

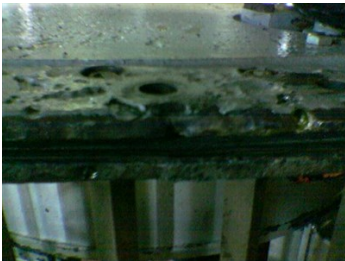
Extensive deep pittings and corrosion all over the large ring led to loss of pressure.

- * Damaged ring ,
- * Surface preparation ,
- * Filling, forming, and coating completed ,
- * Back in operation after two days ,

Bottling ring 2.7 meters diameter severely eroded and corroded.
