Belzona SuperWrap II Patch Repair on Tank

Industry: Chemical & Petrochemical

Customer Location: Caronno Pertusella, Italy

Application Date: 2020

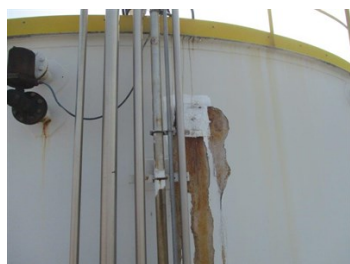
External corrosion on the exterior of a tank causing a loss in material substrate.
