# Paving slab walkway repair with Belzona

ID: 8305

Application: FPA-Floor Problem Areas

Substrate: Stone Paving Slabs

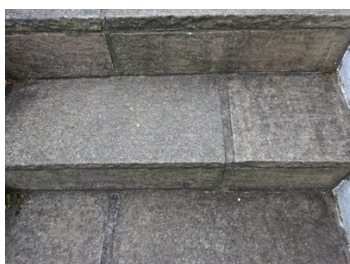
- \* Paving slabs original ,
- \* Wear & weathering of the existing slabs ,
- \* Belzona 4111 colour matched & applied ,

Marshall's paving slabs had been installed on a domestic walkway as step treads. These slabs had started to deteriorate through wear, age & weathering. The slabs had lost their original colour & now had a dull appearance. The slabs were then replaced at the expense of the installer but after a further six years the replacements had also deteriorated. A permanent solution was required.

The Belzona 4111 Base was colour matched to the original Marshall's paving slabs using the Grey/Sandstone shades & cement pigments. Belzona 4911 TX Conditioner was applied to the areas followed by the mixed Belzona 4111 Magma Quartz.
