BELZONA SAVES PLANT \$400,000 PER WEEK

Industry: General Industry
Application: TCC-Tanks and Chemical Containment Areas

Customer Location: Mineral Processing Plant in South Texas
Application Date: Nov/Dec 2006

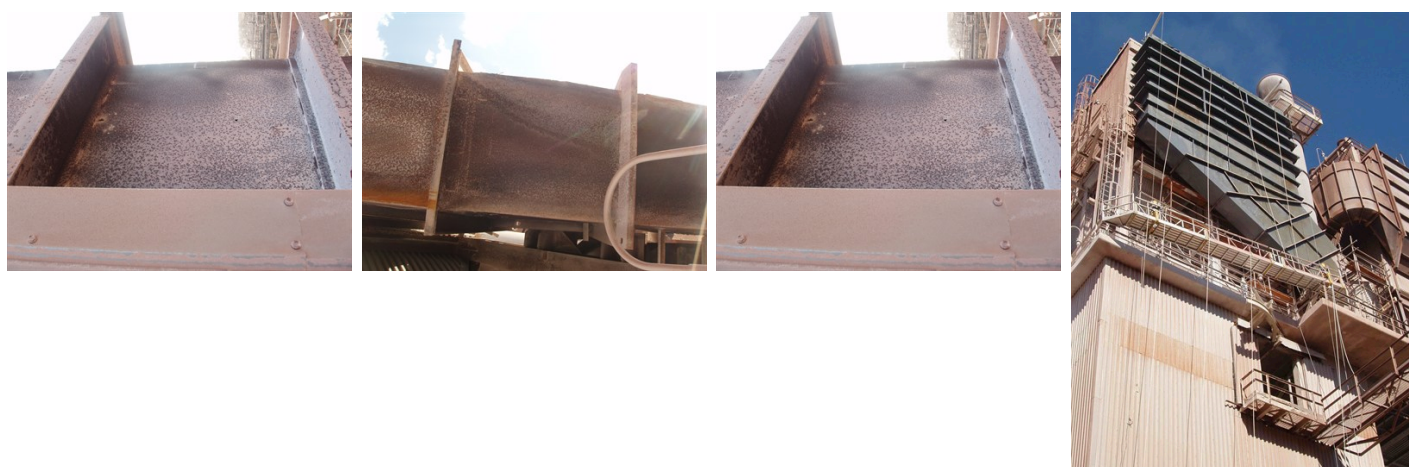
Photograph Descriptions

Air intrusion into ductwork seriously affected plant efficiency

- * Ductwork before work commenced ,
- * Close up of framework showing loose connections ,
- * Another view of framework showing loose connections ,
- * Finished application ,

The steel ductwork had become corroded from salt water spray and NAOH mist. Vibrations from operations caused sections to become disbonded from the framework.

Application carried out in accordance with Belzona Know-How System Leaflet TCC-5. Belzona® 1111 and 1121 were used to bond loose metal to framework when system was out of service and cool. System was then brought up to operating temperature and

Belzona® 5851 was used to coat the repaired areas and the entire surface to prevent further corrosion.
