# Belzona Repairs Screw Feed Trough

ID: 8315

Industry: General Industry  
Application: SHM-Solids Handling Machinery

Restoration of a screw feed trough used for waste management.

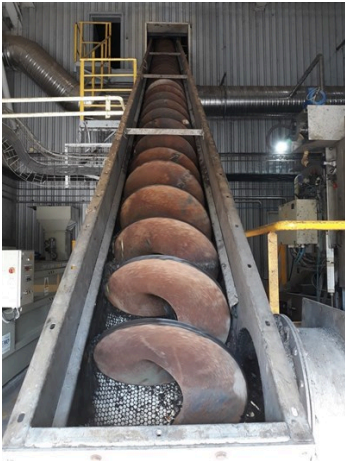
This screw conveyor was used for the movement and separation of media such as glass, plastics and general waste for a landfill site. The harsh media going through the screw conveyor was causing severe abrasion on the screw feed trough leading to regular cracks and repairs through welding, this meant massive regular downtime for the client and they wanted to find a long term solution.

- \* Before application - Previous 1.5m trial section can be seen at the bottom of the feed ,
- \* Close up of the 1.5m trial patch after 6 months in service ,
- \* Start of preparation and application of the Belzona 1814 section ,
- \* Final application ,

This application was carried out in accordance with a modified version of system leaflet SMH-07. The surface of the screw feed trough was prepared and cleaned before the top section of the trough was applied with Belzona 1814, the majority of the trough was then applied with Belzona 1811. The Belzona 9811 alumina tiles were also incorporated with the Belzona 1811 and Belzona 1814 to create a high abrasion resistant system.

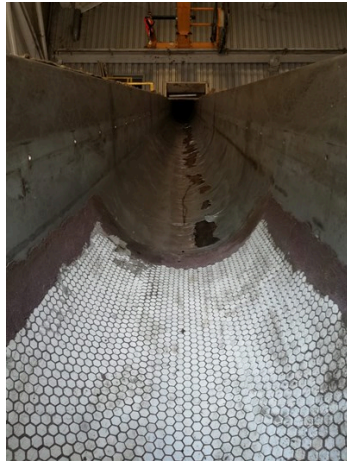
It was agreed a 1.5m trial application would be carried out before the whole screw conveyor was to be repaired as this was the client's first time using Belzona. 6 months after the original trial the results showed the Belzona system to still be in excellent service condition. The client was extremely happy with the results and agreed to proceed with the whole screw conveyor. To follow the strict time scale the whole application was carried out in 2 days and a total of 180Kg of Belzona 1811 and 1814 was used.
