# Belzona Protects Pharmaceutical Plant Floor

ID: 8317

Industry: Buildings & Structures  
Application: FPA-Floor Problem Areas  
Substrate: Concrete  
Products: \* Belzona 5231 (SG Laminate) ,

Customer Location: Italy  
Application Date: 2017

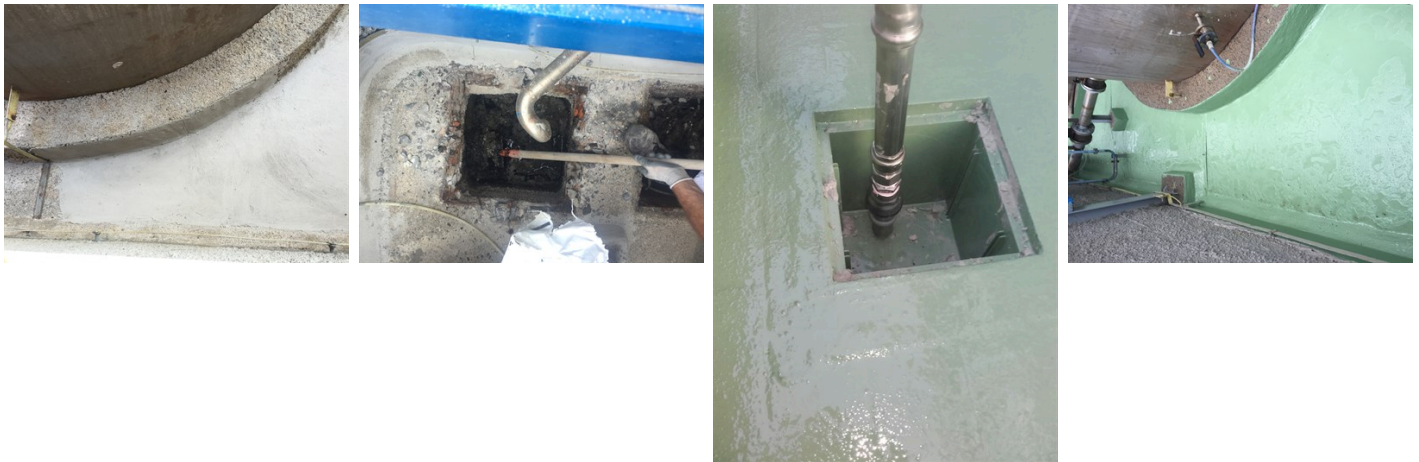
*This plant floor and sump area were located outside and the outdoor roof didn't cover the full area, this was causing the concrete to degrade over time. Also, due to process there was occasional chemical spillages onto the concrete and therefore the client wanted the concrete sealing.*

- \* Before application ,
- \* Before application ,
- \* Final application ,
- \* Final application ,

Installation of a new positive grip flooring system on an outdoor concrete floor.

This application was carried out in accordance with system leaflet FPA-03. The concrete floor was prepared through grinding and cleaned before applying the Belzona 5231 with rollers.
