# Pharmaceutical Company selects Belzona 4181

Industry: Food & Drink  
Application: TCC-Tanks and Chemical Containment Areas  
Substrate: Concrete  
Products: \* Belzona 4181 (AHR Magma-Quartz) ,

Customer Location: Finland  
Application Date: July, 2020

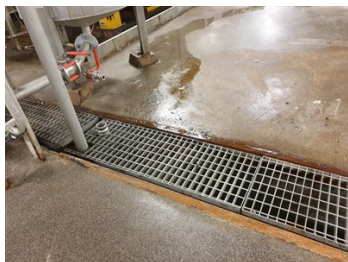
The historic flooring had insufficient gradient for the chemicals to lead into the channels therefore the chemicals were pooling on the floor close to the channel, the old channels had weld seams which was causing leaks. This year the client needed to repair the drain-channels in the process basement and the distillery. There were two different problems. Problem One: The old factory (to be taken out of production in a couple of years), the flooring around the channel was deteriorated and uneven, and caused chemical waste to be lying still, without running down in the channel for transportation to the waste treatment process. Problem Two: The distillery area, waste channels needed a coating, due to weld seams that had cracking. The client requested the bottom of the whole channel to be coated, and also the sides.

- \* Problem of chemical sitting on the floor area ,
- \* Application of Belzona 4181 complete ,
- \* Waste Chemical Channel deteriorated. ,
- \* Waste Channel Repaired with Belzona 4181 ,
