BELZONA ELASTOMERS IDEAL FOR HIGHWAY REPAIRS

ID: 832

Industry: *Buildings & Structures*
Application: *SHM-Solids Handling Machinery*

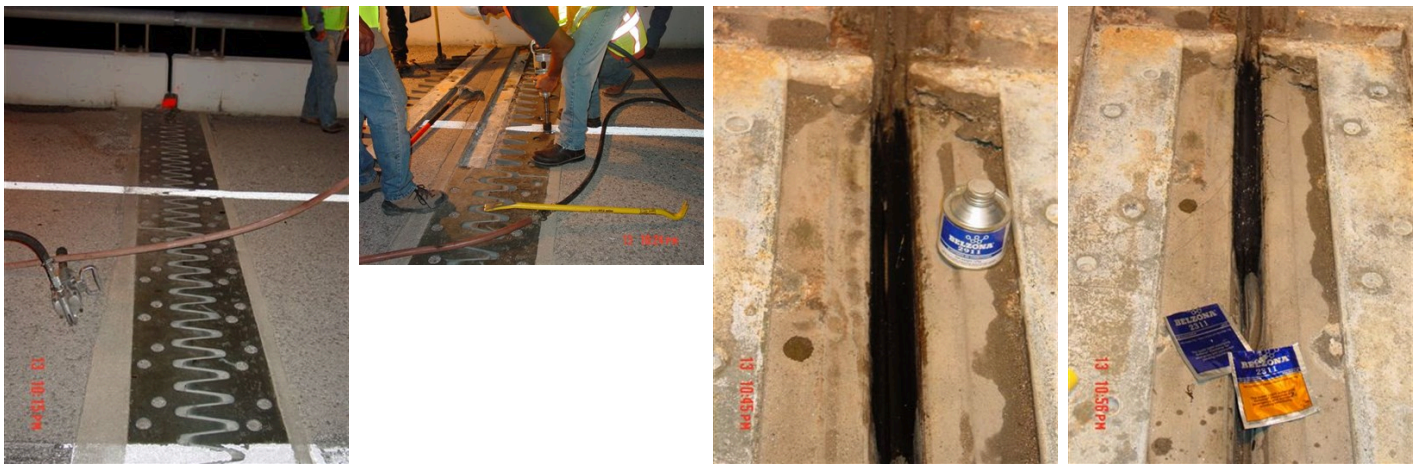
Photograph Descriptions

Rubber joint sealant became torn and ripped from traffic etc. A fast durable repair was sought instead of replacement of the joint seal.

* Large highway expansion joint , * Grate over sealant removed , * Torn rubber was cleaned, roughed up and conditioned , * Finished repair ,

Application carried out using modified version of Belzona Know-How System Leaflet SHM-9. Areas were cleaned and roughened up using the Belzona roughing brush. Belzona® 2911 was applied and followed by Belzona® 2311.
