Rubber lined ionization chamber repaired

ID: 8322

Customer Location: Pharmaceutical Manufacturer in Hungary

Application: SHM-Solids Handling Machinery

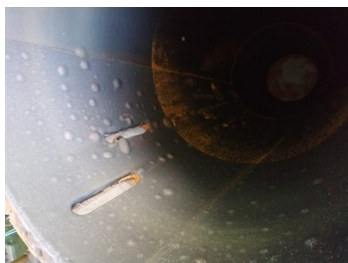
Damage of the original rubber lining of an ionization tower.

- * 1. Damaged rubber lining ,
- * 2. Removing of damaged lining and surface preparation ,
- * 3. Second layer of Belzona 2121 being applied ,
- * 4. Finished application ,
