BELZONA REPAIRS AND SECURES FLOORS AND STAIRS

Application: *FPA-Floor Problem Areas*

Customer Location: *Housing association, Georgia, US*

Problem

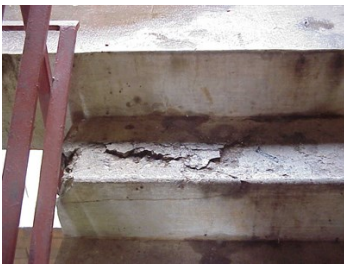
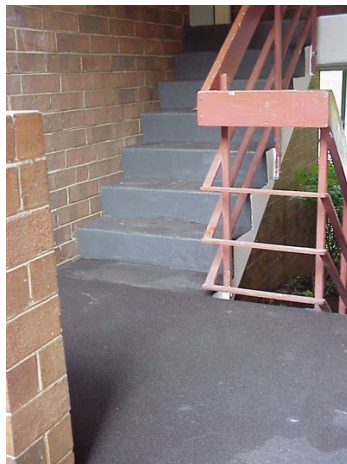
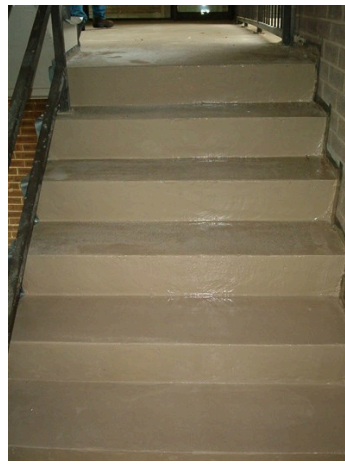
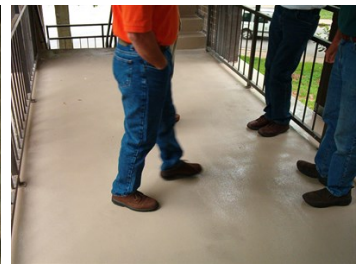
Spalled concrete due to water damage over time.

- * Damaged stairs. ,
- * Completed repairs and coating, with Belzona® 5811 mixed with a light coat of sand. Undersides of the stairwell were coated with Belzona® 3111. ,
- * Areas repaired with Belzona® 4111 & 4141. ,
- * Finished view of the project. ,

The worn concrete in this public building had become a health and safety hazard. Damaged areas were rebuilt with Belzona® 4111 & 4141. The underside of the stairwells was coated with Belzona 3111 to prevent moisture from entering the concrete. Belzona® 5811 was used to protect the stairs and balconies, and a non-slip system was created by incorporation of aggregates mixed into the Belzona® 5811. Three years later, this application was still in great condition with only a few areas needing to be touched up.
