# Belzona SuperWrap II used for a pipe repair

ID: 8332

Customer Location: Petrochemical company, Slovakia

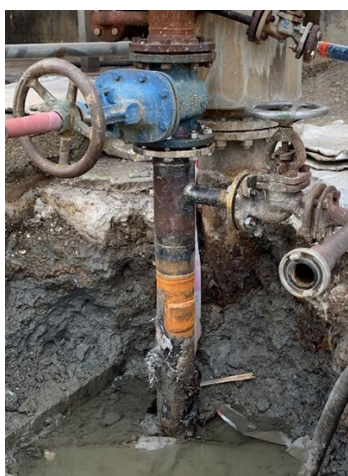
\* 1.Underground pipe had developed thin-wall defect 2.The surface was blasted to the 75 microns profile and cleanliness Sa 2,5. 3. All system then was wrapped to Belzona 9382 4. Super Wrap II ready for use ,

The customer recorded water leakage in system. Underground pipe had developed thin-wall defect. They tried to weld this damaged place several times. On the thin wall they found permanently new damages (also like thermal influence from welding)
