Belzona 2311 repairs Waste Incineration Plant Conveyor Belt

ID: 8347

Industry: *Water / Wastewater*
Application: *SHM-Solids Handling Machinery*

Customer Location: *Switzerland*
Application Date: *June, 2019*

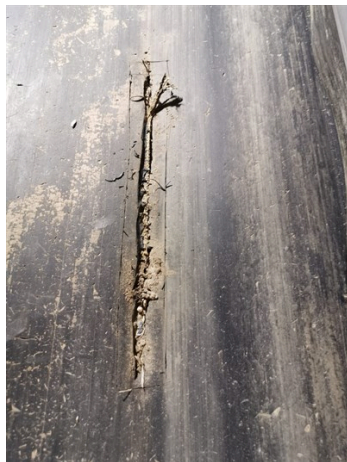
There were a number of tears in the conveyor belts due to the medium that was being transported along the conveyors. If the belts had torn completely the waste would have spread all over the internal of the operation and also the whole plant would have to be shut down to repair.

- * Picture 1 - Conveyor System ,
- * Picture 2 - Conveyor Belt Tear ,
- * Picture 3 - Belzona 2311 ,
- * Picture 4 - Application Complete ,
