# Belzona 2311 repairs Waste Incineration Plant Conveyor Belt

ID: 8347

Industry: *Water / Wastewater*  
Application: *SHM-Solids Handling Machinery*

Substrate: *Rubber*  
Products: *\* Belzona 2311 and Belzona 2911 ,*

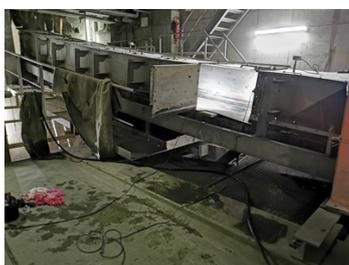
- \* Picture 1 - Conveyor System ,
- \* Picture 2 - Conveyor Belt Tear ,
- \* Picture 3 - Belzona 2311 ,
- \* Picture 4 - Application Complete ,

A conveyor belt had torn during operation within a waste incineration plant. Conveyor belts transport biomass from the waste heap to shredders or transfer stations.

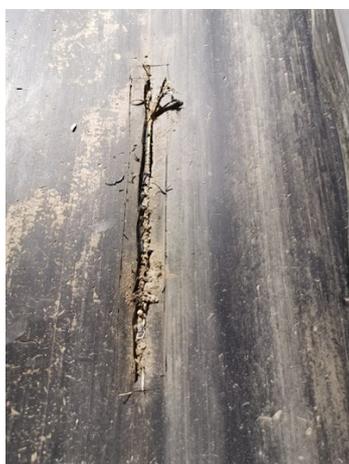
*There were a number of tears in the conveyor belts due to the medium that was being transported along the conveyors. If the belts had torn completely the waste would have spread all over the internal of the operation and also the whole plant would have to be shut down to repair.*
