# Belzona Repairs, Protects & Improves Pump Turbines in the Petrochemical Industry

ID: 8349

Application: *CEP-Centrifugal Pumps*

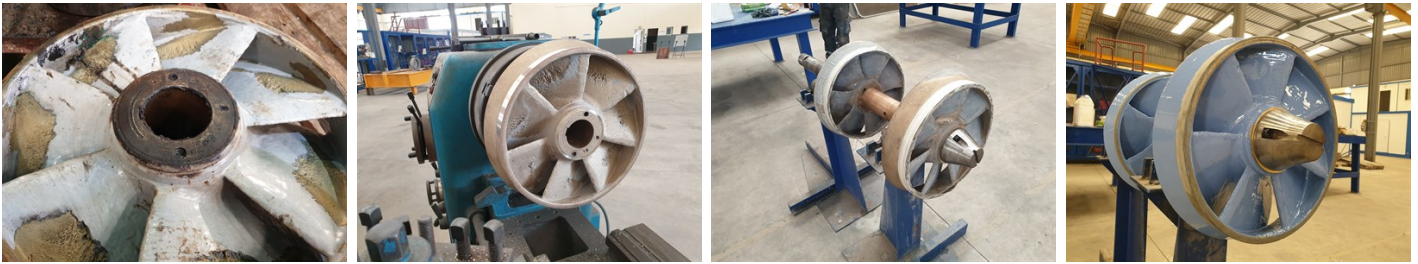
*Water pump impellers were suffering extensively from cavitation and erosion.*

- \* 1). Damage sustained on the impeller ,
- \* 2). Impeller once taken back to the substrate ,
- \* 3). Impeller after rebuilding ,
- \* 4). Finished product ,

The application was carried out, in accordance with Belzona System Leaflet CEP-01 and CEP-10, where the damaged areas were rebuilt using Belzona 1111 and then coated with Belzona 1341 to predominantly solve the clients cavitation problem.
