Belzona Repairs, Protects & Improves Pump Turbines in the Petrochemical Industry

ID: 8349

Application: CEP-Centrifugal Pumps

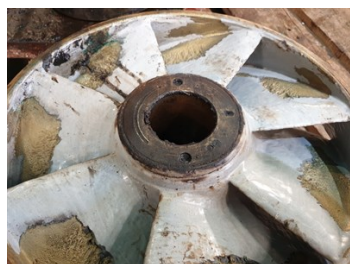
Water pump impellers were suffering extensively from cavitation and erosion.

- * 1). Damage sustained on the impeller ,
- * 2). Impeller once taken back to the substrate ,
- * 3). Impeller after rebuilding ,
- * 4). Finished product ,
