Welding seams protection

ID: 8360

Industry: *Chemical & Petrochemical*
 Application: *TCC-Tanks and Chemical Containment Areas*
 Substrate: *Carbon steel*
 Products: *Belzona 1341,*

Customer Location: *Petrochemical company, Slovakia*
 Application Date: *October 2021*

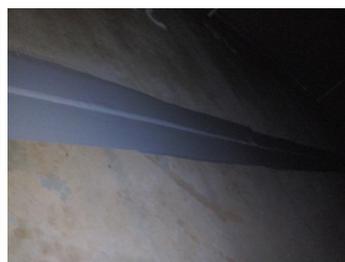
Welding seams was coated by Belzona 1341

After 4 years no damage was appeared.
