# BELZONA PROTECTS SHIP SCRUBBER SYSTEM DISCHARGES

ID: 8361

Industry: *Marine*  
Application: *SOS-Ships and Offshore Structures*

Customer Location: *SHIPYARD, TURKEY*  
Application Date: *January 2018*

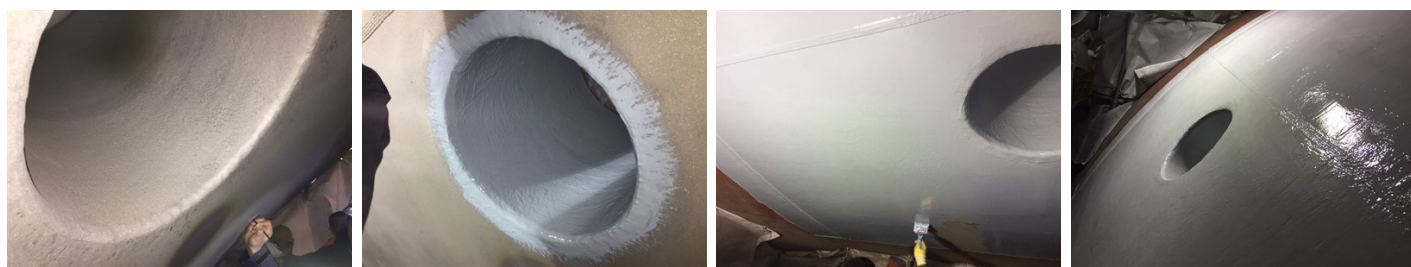
*After the installation of the scrubber system discharge pipe, the chemicals included in the system such as sulfuric acid and sodium hydrogen sulphate and etc. will have aggressive corrosive effect on the steel discharge pipe and area around the ships steel hull. Combined with the severe cavitation effects, the area is under heavy risk of metal loss due to cavitation damage.*

Scrubber Overboard Discharge area of RO-RO ship

The application was carried out in accordance with Belzona Know-How System Leaflets SOS-02. Surface was grit blasted to achieve SA2,5 standard. Surfaces salt contaminant measured and surface has cleaned with Belzona 9111 Cleaner&Degreaser. Specified Surface area is coated with 2 layers with Belzona 1391T. After the application, coating allowed to cure and postcured respectively.
