Belzona Seals a Wind Turbine Tower Base

ID: 8375

Industry: Power
Application: GSS-Gaskets, Seals and Shims
Substrate: Steel & Concrete C32/C40
Products: * Belzona 3131 WG Membrane ,
* Belzona 3921 & 3931 Conditioners ,
* Belzona 9361 Reinforcing Sheet ,

Customer Location: South Wales UK
Application Date: July 2020

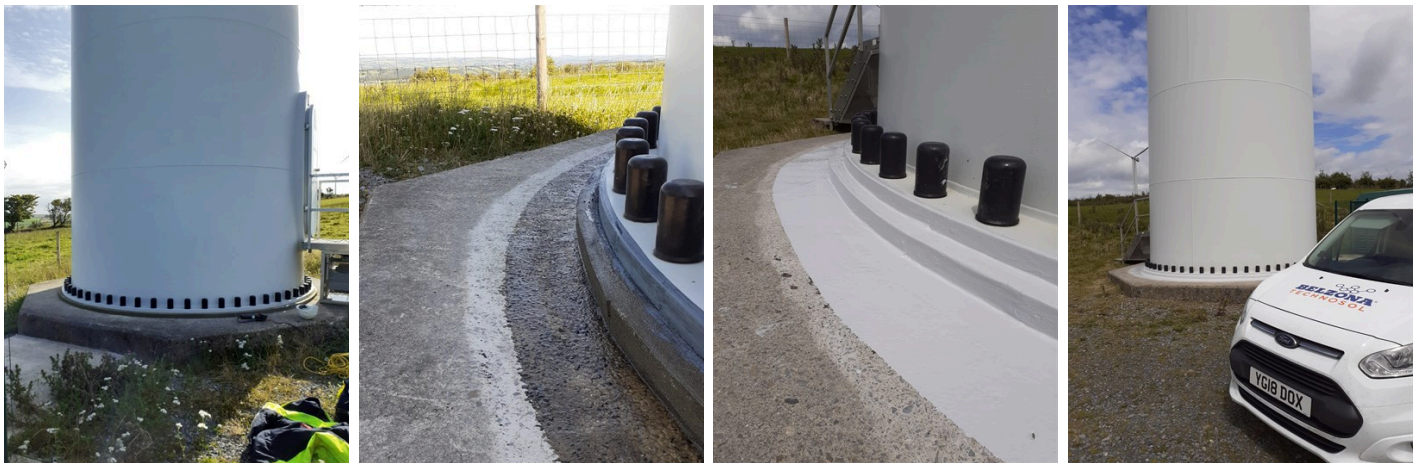
Photograph Descriptions

The contractor sought guidance as there were several areas showing signs of metal corrosion and minor cracks to the concrete areas of two bases. A repair and protect solution was required to ensure the asset life could be fully extended a further ten years.

- * 1 - Visual preparation ,
- * 2 - Surface preparation, concrete, steel and conditioners ,
- * 3 - Two coat system including reinforcing sheet ,
- * 4 - Fully completed ,

The application was carried out in accordance with a variance of GSS-03
